# INVESTIGATION OF THE STRESS-CORROSION CRACKING OF HIGH STRENGTH ALUMINUM ALLOYS

ALUMINUM COMPANY OF AMERICA  
Alcoa Research Laboratories  
Chemical Metallurgy Division  
New Kensington, Pennsylvania

Summary Report

(Period of May 6, 1963, to July 6, 1965)

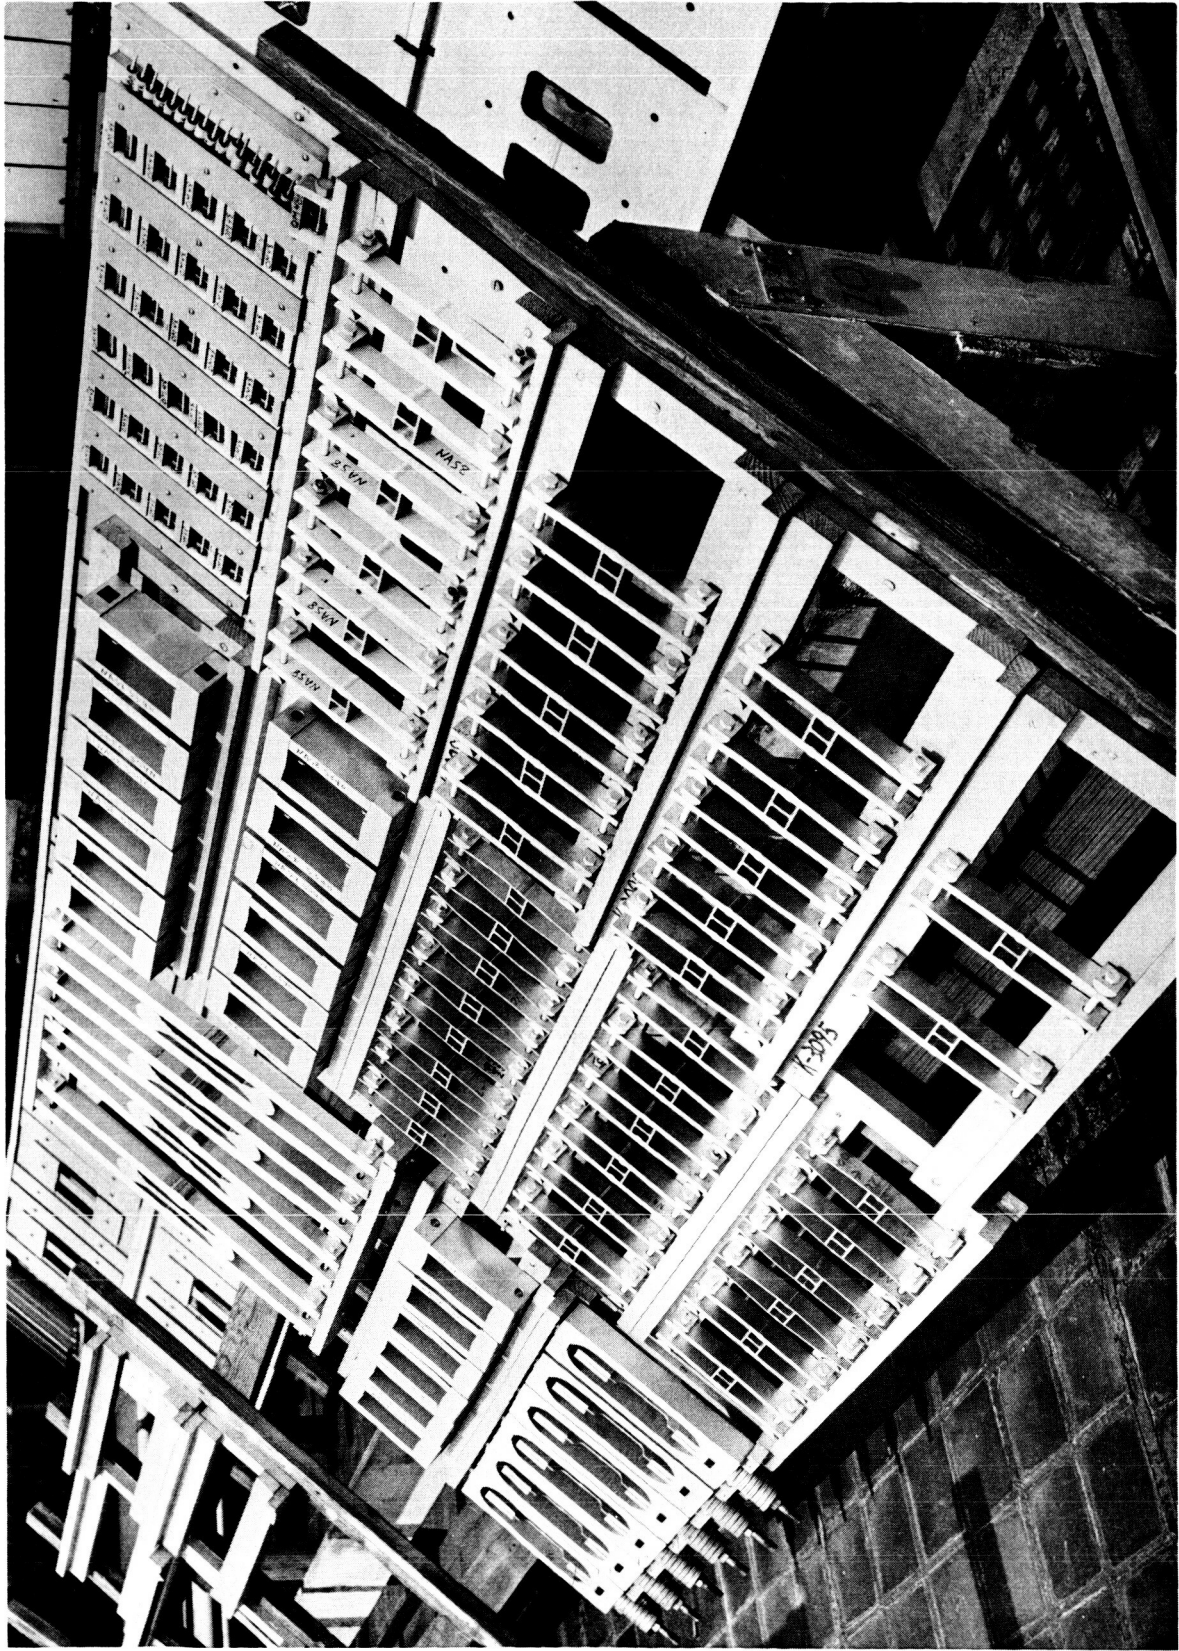
Figure 2 - Portion of the New Kensington Atmosphere facility

The specimens were exposed to four environments (3.5% NaCl alternate immersion, New Kensington industrial atmosphere (Figure 2) and Point Judith and Point Comfort seacoast atmospheres) according to the schedule given in Table V. Certain stressed specimens for the New Kensington and Point Comfort atmosphere were exposed with an intentionally damaged coating. The technique employed was a peripheral scribe mark along the center line of the 1/2" width, machined through the coating to a depth of  $2 \pm 1$  mils into the underlying metal.

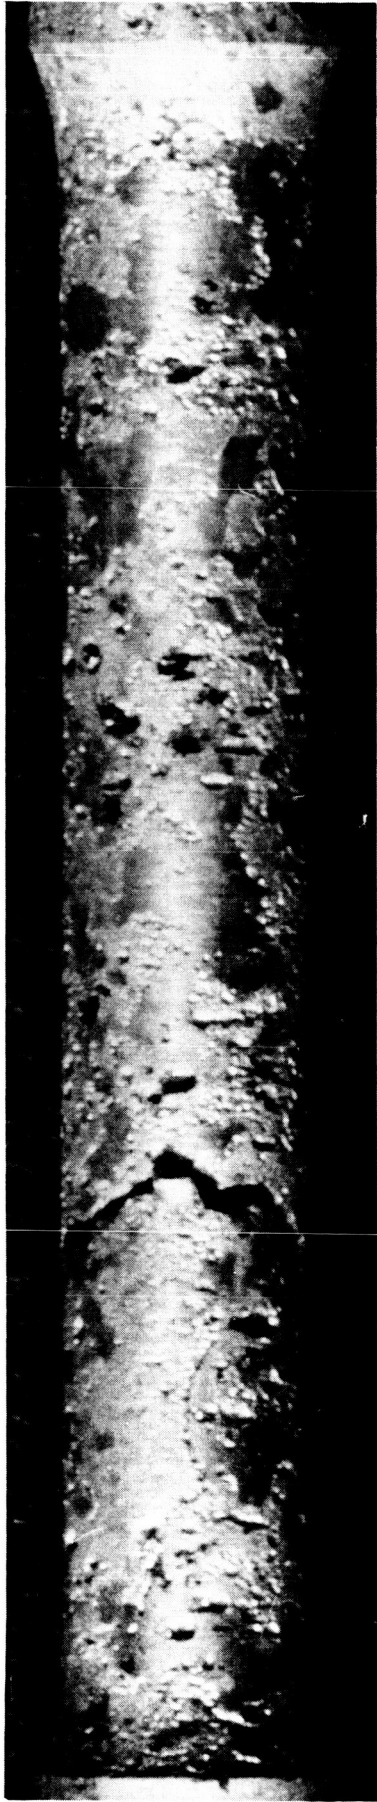
Figure -20

Bottom S - 320215 -T18 - Exposed 7 days in "G" electrolyte, 10% loss in T.S.

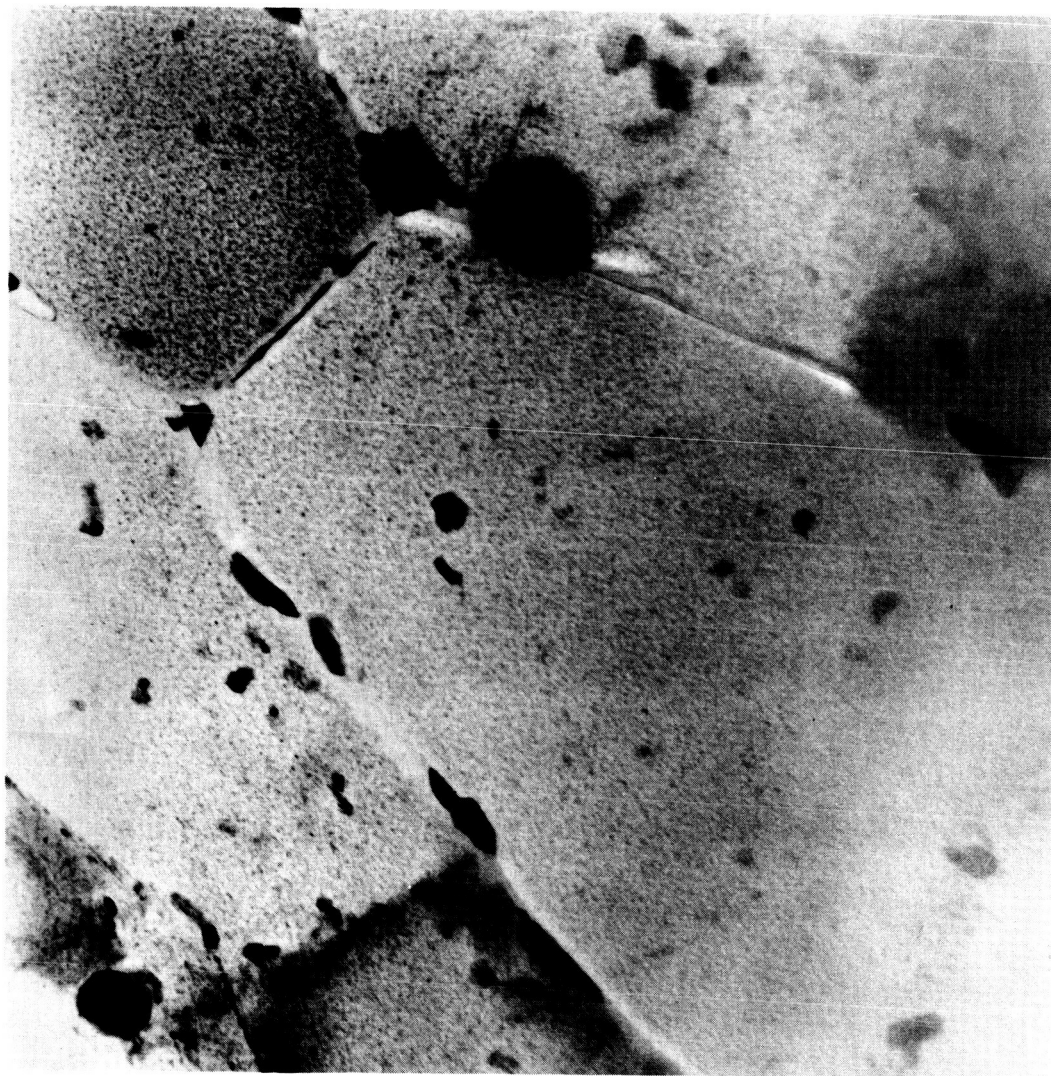
Mag: 50,000X

Figure 48 - Electron micrograph of the fusion zone penetrated by stress-corrosion cracking of post weld aged X7106-T6351 plate (3/8" thick). Shows the small polygons in the fusion zone, the marked degree of zoning in the matrix, large M-phase precipitate particles on the grain boundary and the zone-free grain boundary paths
